The X-43 Fin Actuation System Problem – Reliability in Shades of Gray

Curtis Peebles*

NASA Dryden Flight Research Center, Edwards, California, 93523-0273 USA

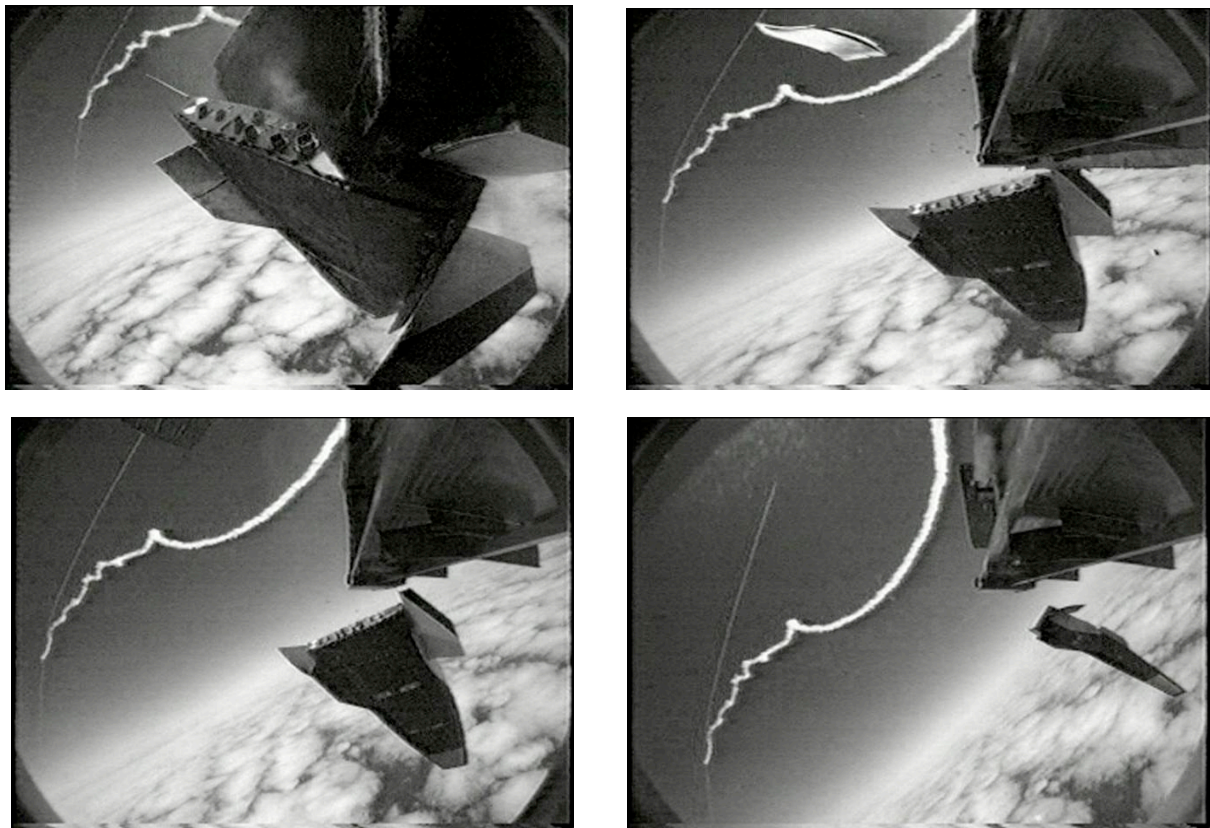
The first X-43A launch was made June 2, 2001. The HXLV's rocket ignited 5.19 seconds after release from the B-52B. The HXLV began to accelerate, then pitched up into the ascent flight path at 8 seconds after launch. At 11.5 seconds after launch, the HXLV began a divergent roll oscillation. This 2.5 Hz-frequency roll oscillation continued to diverge for the next second and a half. The rudder's EMA then stalled and ceased responding to the flight computer commands. With the loss of rudder control at about 13 seconds after launch, the vehicle began to yaw, reaching a sideslip of more than 8 degrees. The resulting high aerodynamic forces caused a structural overload of the starboard elevon 13.5 seconds after launch. The elevon then broke off, followed by the other two fins. Following the loss of control, the range safety officer activated the flight termination system.

The X-43A Mishap Investigation Board (MIB) was convened on June 5, and worked for the next nine months. The board concluded that the failure was due to modeling inaccuracies in the FAS and aerodynamics, both Pegasus-heritage and HXLV-specific, as well as insufficient variations in the modeling of the parametric uncertainty analysis.⁷

Figure 3. This series of images shows the first X-43A as it breaks free of the HXLV.
